TOWN OF SNOW HILL

BYRD PARK FLOODING, STORMWATER, AND SUBSIDENCE ASSESSMENT

PRELIMINARY ENGINEERING REPORT

SEPT. 2022

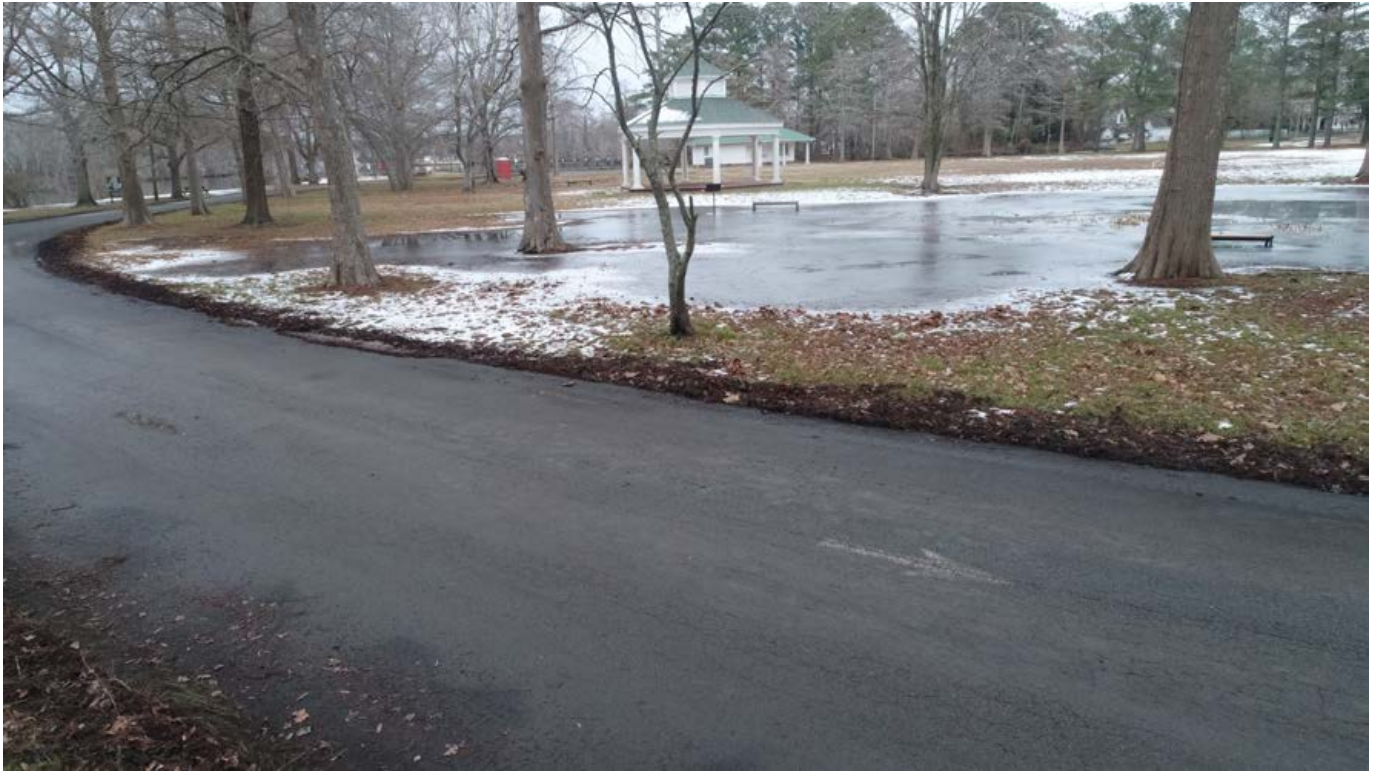
IMAGE 3: DOCUMENTED PONDING/FLOODING IN JANUARY 2022

park appears to flood frequently. This may be due to water penetrating the bulkhead or water being trapped behind the bulkhead during flooding events. Flooding has been noted along the edges of roads within the park at several locations. The multiple grass fields and the playground area on the southwest of the park have been found to pond water at varying levels of severity. The more severely affected areas having 6" or more of ponding remaining for a week or longer.

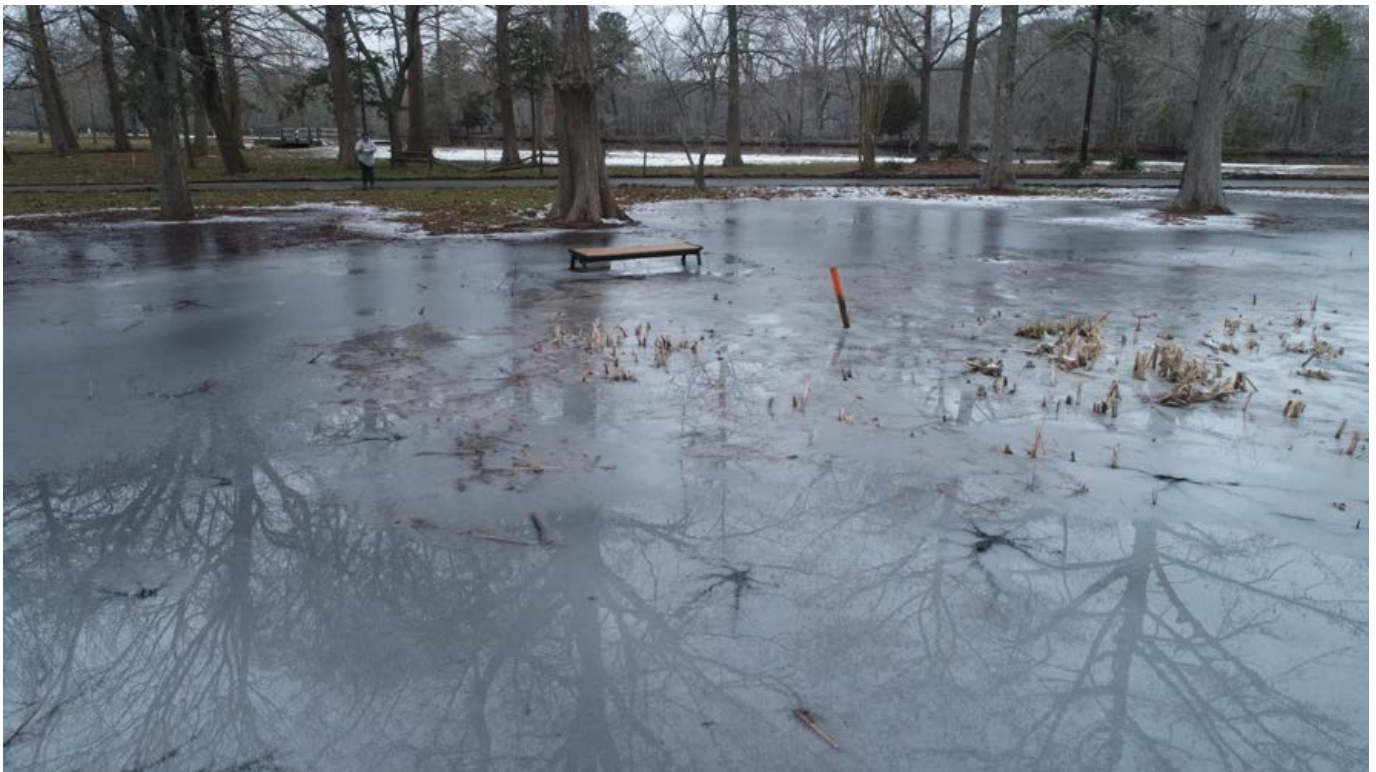
IMAGE 4: DOCUMENTED PONDING/FLOODING IN JANUARY 2022
